**Glacio-lacustrine Deposits Create Landslide Hazards at  
Deer Run Heights in Jeffersonville, Vermont**

Michaela Forsberg  
Johnson State College  
20-July-07

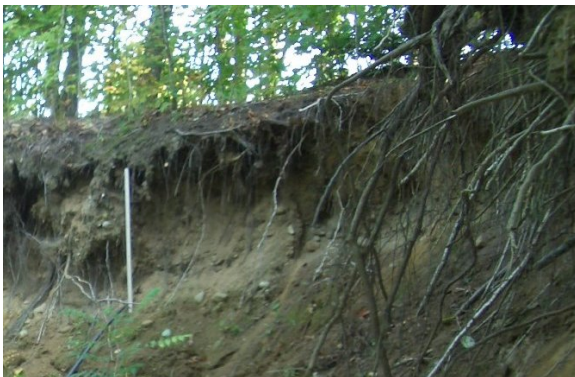
**Figure 3. Undercutting of Soil Horizons**

One of the problems encountered while measuring the amount of cut back on the ridge was that there didn't seem to be any change in the measurements. Visually the loss of sediment was noted in the amount of material found down slope and the increase in undercutting as seen in

Figure 3. The roots of trees and grass keep the cutback of the ridge line at a minimum by holding the soils together while the slope fails below. This kept the measurements from changing a great deal although the loss of sediment was visually apparent.

This illustrates the importance of vegetation in keeping a slope stable. However, once the

support of the trees and other vegetation is sufficiently compromised, it will fail. This pattern will continue until the slope reaches a lower angle of repose and stabilizes (Montgomery, 2006). According to Mr. McCuin and Mr. Farara, who are the owners of the two adjacent properties threatened by slope failure, Figure 3 is the top scarp of a gully formed as a result of a water hose left on in 2003 (Springston, 2006). This gully is the northern border of a small scale mass wasting event which occurred sometime in late June to early July of 2006.

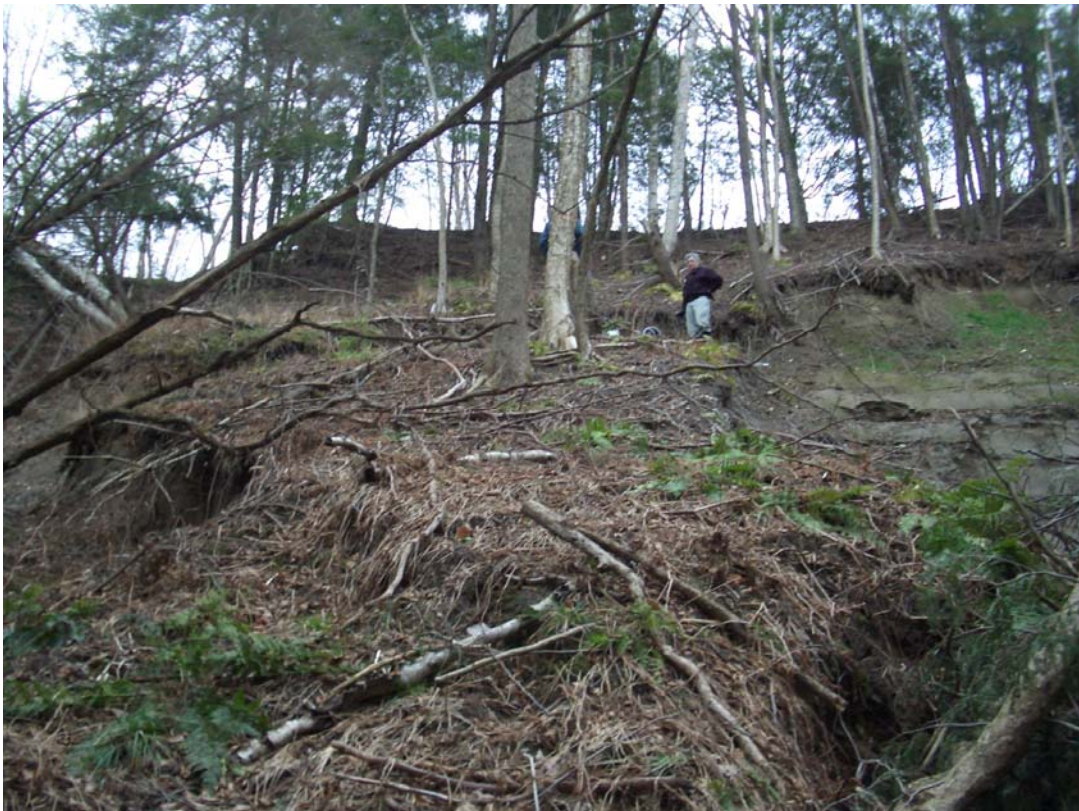
**Figure 4. McCuin and Farara slides**

The 2003 McCuin slide is visible on the left of Figure 4, and the 2006 Farara slide on the right. In between is a new rotational slump. The scarp at the top of this slump shows about 0.5 meters of displacement down slope, and it will continue to move because of the steep nature of the slope and the fine clays, silts and fine sands which are present in this area.

Currently this area is plagued by many small scale slides; prior to the 1999 slide similar small-scale recurring slides were observed (Wright, 1999). These small scale slides may have a similar effect in further destabilizing the slope, much like a road cut can sometimes destabilize a slope by removing material from down slope. As the base of support is removed the weight of the overlying hill could overcome the frictional forces which keep this slope at a tentative equilibrium (Sidle and Ochiai, 2006). Loss of support due to high rates of erosion and small scale landslides, sensitivity to water, and the presence of a perched water table (Wright, 1999) may make this area the location of the next large landslide.

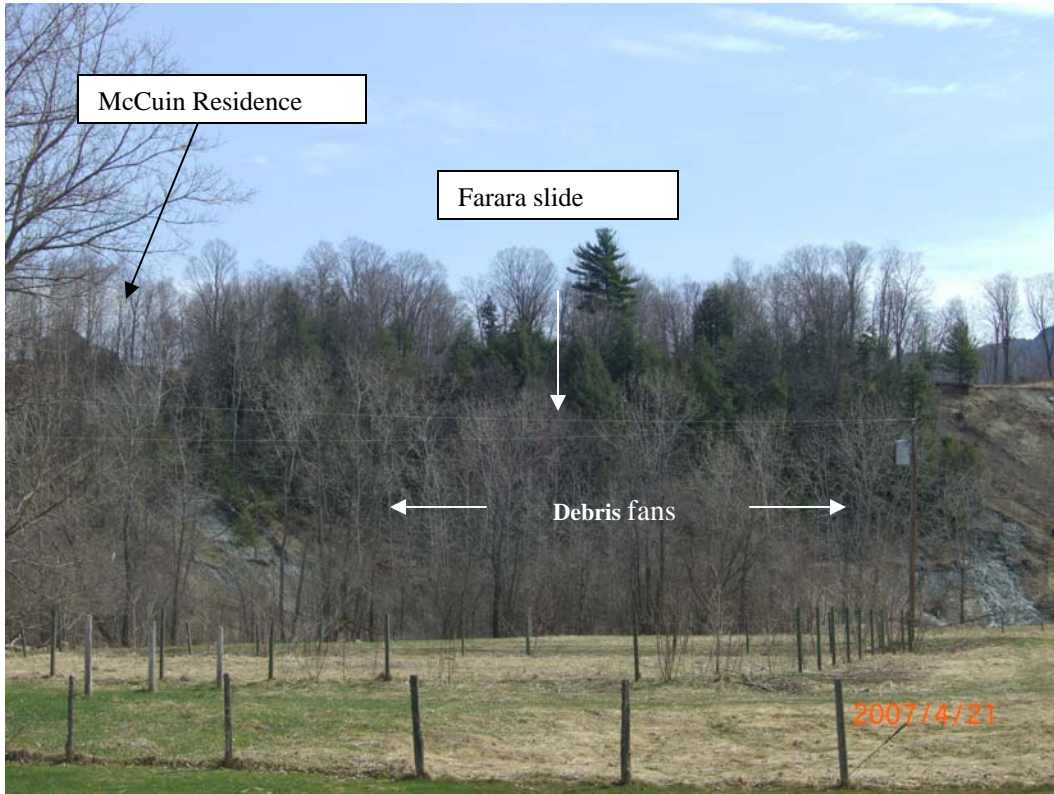
**Figure 6. Deer Run Heights**

Further down slope, the rotational slide turns into an earth-flow which is a type of mass wasting caused by water which mobilizes the soil on a hillside (Baskerville, Lee, and Ratte, 1993). After the early spring nor-easter which lashed Vermont with torrential rain, high winds and heavy wet snow, two large debris fans were noticed at the toe of the slope not far from the Brewster River (Sutkoski, 2007; Figure 6).

Earth flows on the toe of a slope have been associated with rotational slumps, and water was observed piping from between layers of fine sand and silt, a good indication of the wet conditions (Baskerville and Ohlmacher, 1988). These debris fans become more noticeable every time it rains because of this soils tendency to flow.

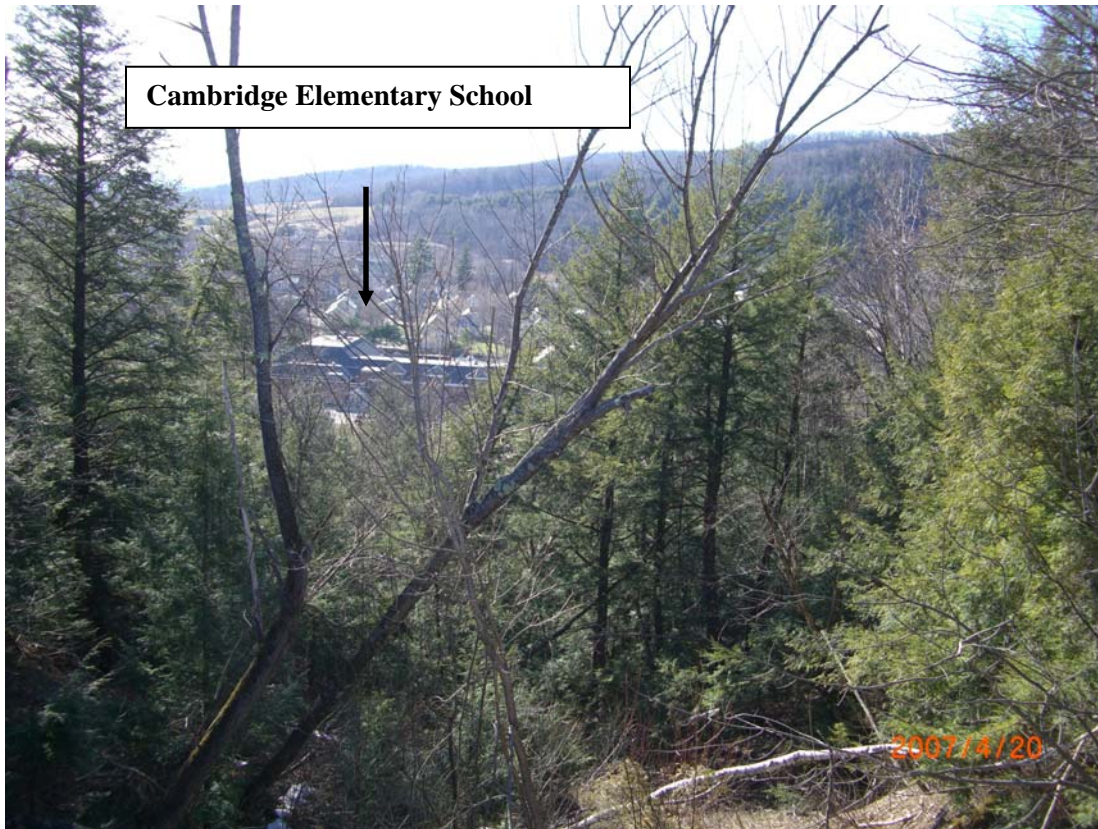
**Figure 7. Gully with Cambridge Elementary School visible in the Distance**

Further south is another gully which is actively eroding. This area is very steep and water was observed seeping from between layers of soil in a similar fashion as near the Farara slide.

This gully is large, about 36 paces or 55 meters long across the top and it narrows near the bottom. Rate of cutback is rapid in this area, and measurements must be taken carefully because of severe undercutting of soil horizons at the top of the scarp. This site should be carefully monitored because of the danger it poses to the elementary school which is clearly visible from the top of the hill.

The 1999 slide material was extremely mobile and threatened residents 150 meters away from the slide (Wright, 1999). The extreme mobility of the 1999 slide may be a good indication of how far material may flow should this area fail, and this distance may be great enough to put the school, which is approximately 120 meters away from the ridge, in harms way.
