**Unstable Lake Sediments of Deer Run Heights  
Represent a Potential Landslide Hazard  
to the Cambridge Elementary School in Jeffersonville, Vermont**

Adam Banks

Submitted to Les Kanat  
Professor of Geology  
at Johnson State College

March 17, 2009

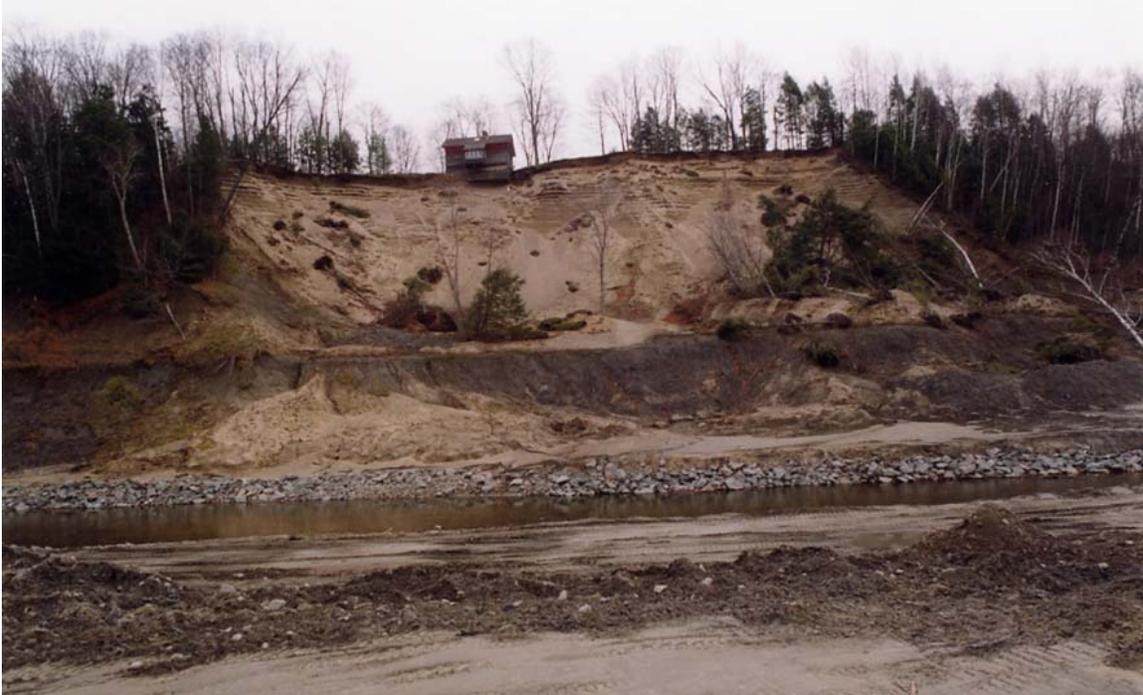
Figure 1. Landslide initiation after drought at Jeffersonville, Vermont (Nichols N.D.)

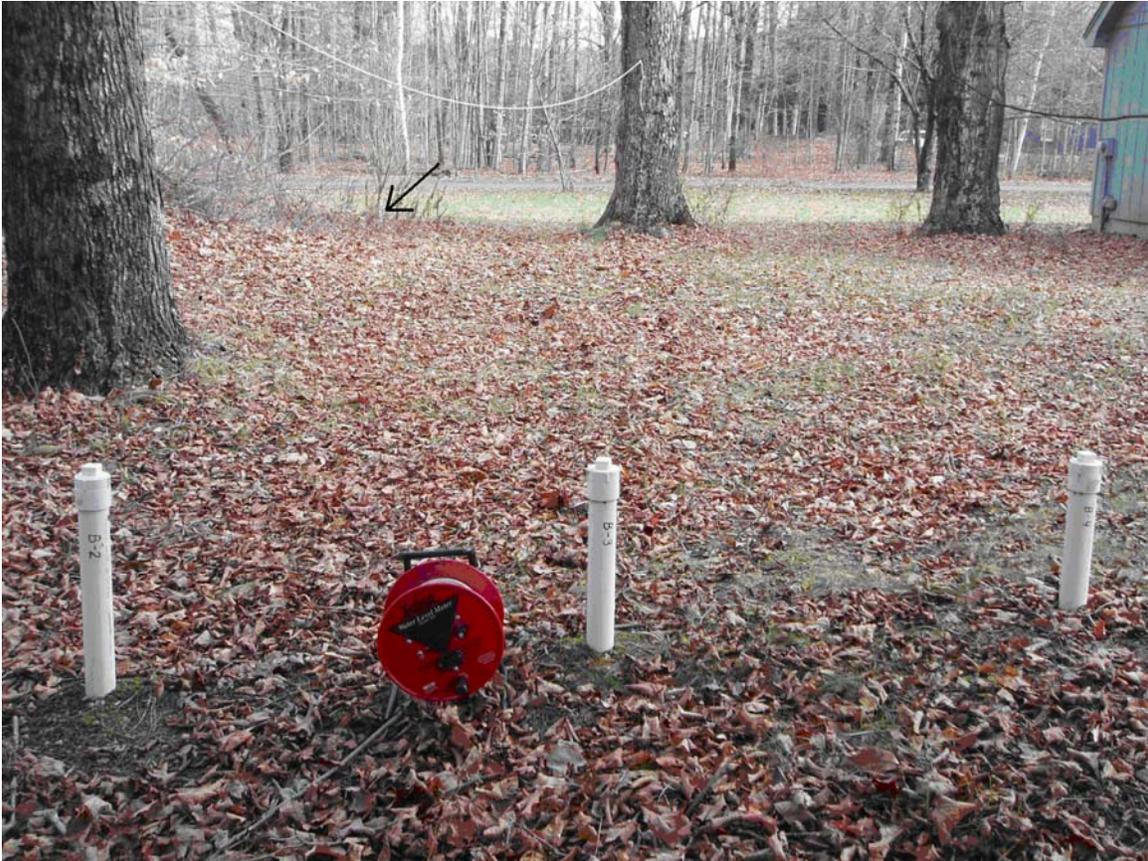
The water level in the four monitoring wells on the Farara property has been monitored for water depth near the edge of the slip face (Figure 2). A water depth instrument, model 101 by Solinst, is used to monitor the water level in each well. A sensor attached to a tape measure is run down the PVC pipe until a beeping sound can be heard from the unit. The depth of the water is recorded at the top of the PVC piping.

**Figure 2. Four Monitoring Wells (the fourth well is behind the brush in the upper left corner)**

The monitoring wells did not prove to be that helpful in the evaluation of saturated sediments near the slip face. This is most likely because the wells were not dug deep enough and water was only detected in well B-2 (Figure 5). Also these wells can potentially produce much different readings during the spring time thaw.

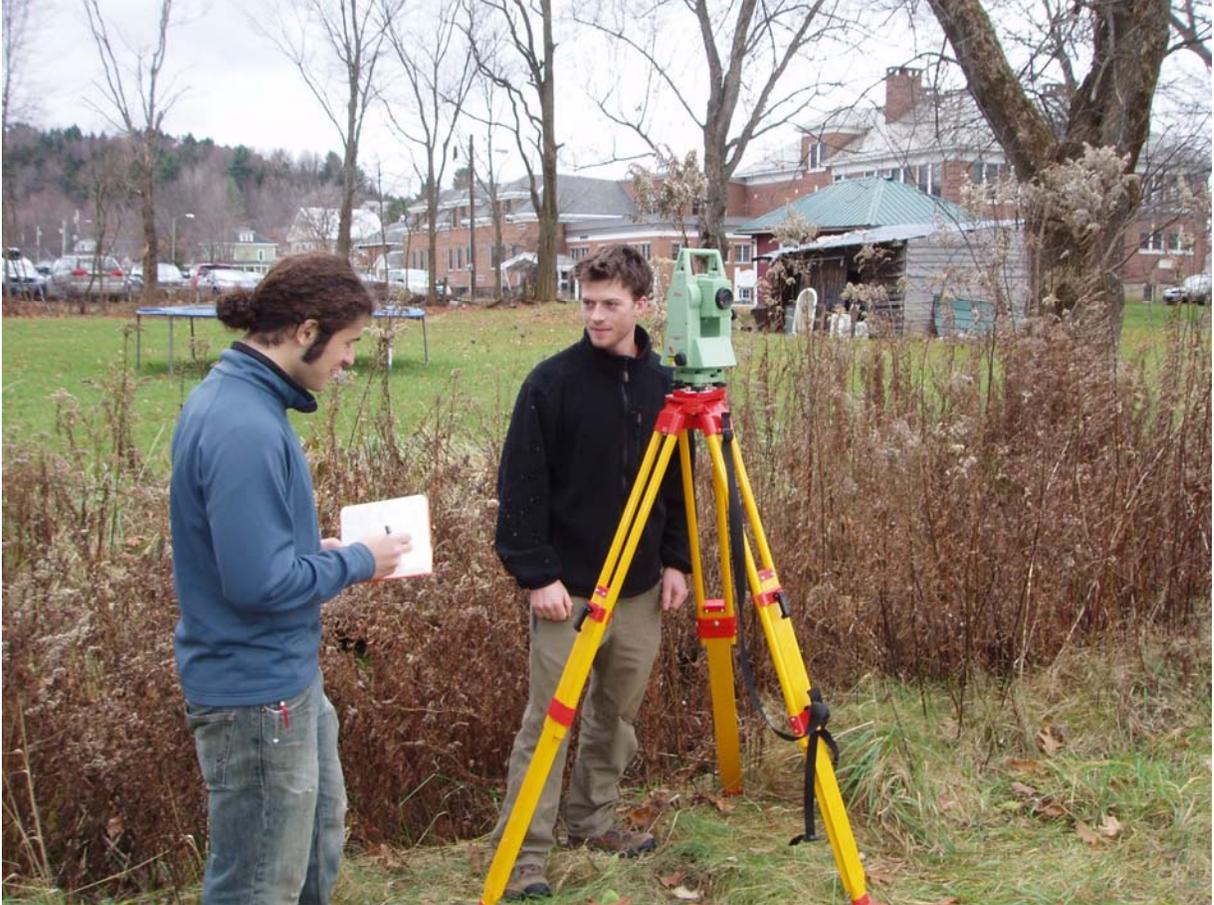
**Figure 4. Sam (left) receives coordinates from Adam (right) on Point 16 back sighting Point 15.**

Since the elevation had been determined and the waypoints had been made using the stakes, the surveying using the highly accurate Total Mapping Station was performed on the traverse. The Total Mapping Station used was model Leica TC407. Stake One of nineteen was used as the first point on the western side of the field above the Elementary School. To use the Total Mapping Station many steps must be taken to achieve precise measurements. First, the unit was mounted directly above the nail head on Point Two and made level using the rough leveling bubble. The unit was then turned on and emitted a laser dot to precisely mount the unit directly above the nail. After this was accomplished, the leveling was fine-tuned before moving on to set up the Station properly. Temperature and relative humidity were entered into the unit to increase accuracy of the laser. The coordinates were initially set to originate at 1000 North, 1000 East, and 1000 Height (elevation). This was done in hopes that no negative numbers were recorded during the surveying. The height of instrument was entered into the unit as well as the height of the rod. From Point Two, a back sight was taken to Point One where a rod was held directly onto the point. The coordinates were shot with the laser and recorded. The coordinates for North, East and Height were recorded in the unit as well as written down (Figure 4).

The rod was then brought to Point Three and a foresight was taken in a similar fashion (the station did not need to be reset or re-leveled for the foresight). This process was repeated throughout the traverse. At every point the Total Mapping Station was set up and packed away in its case for protection while moving it. A back sight and foresight were taken at each point to ensure accuracy and to evaluate if any mistakes were made.

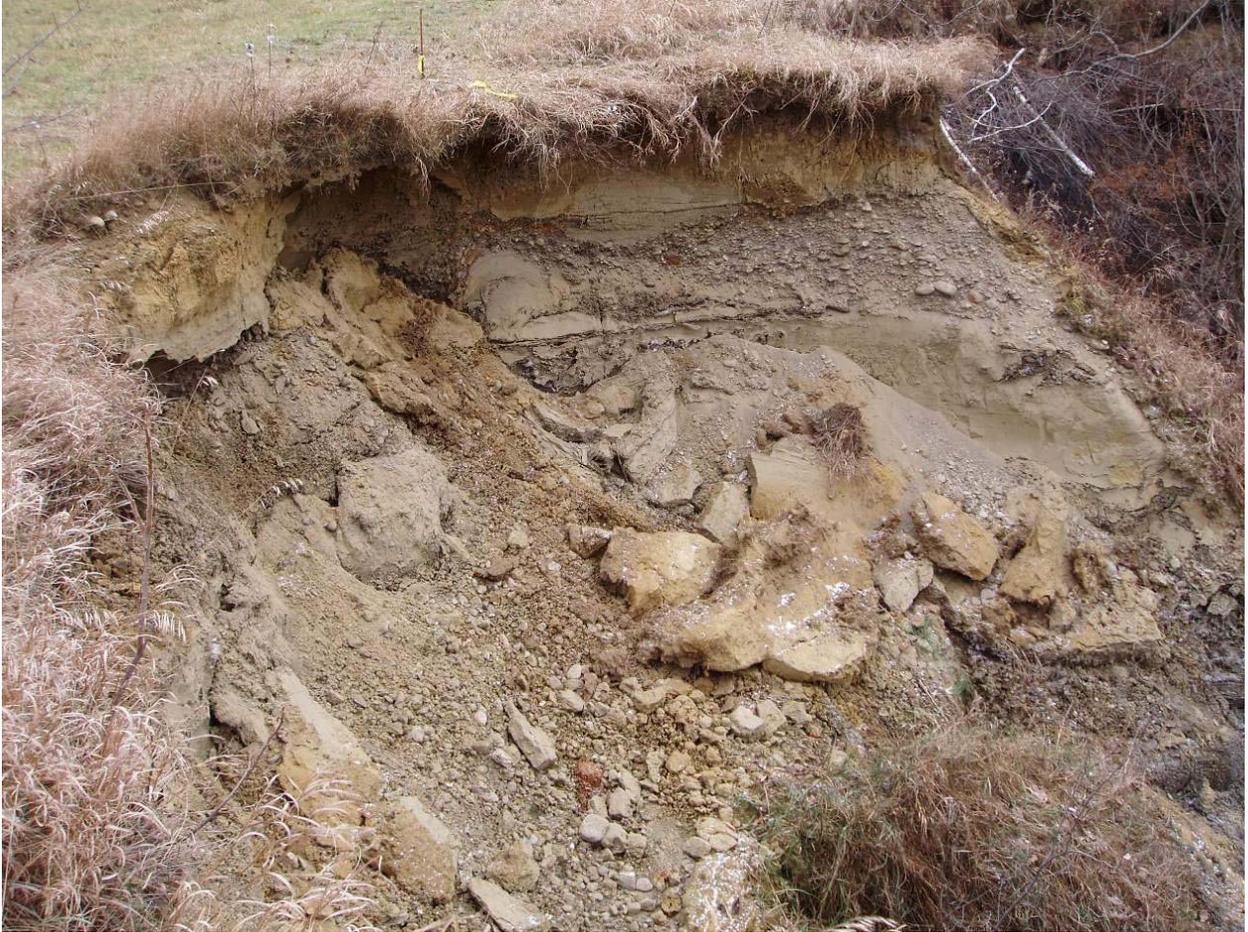
Stake 16 produced the most significant results of the study being located directly above the Jeffersonville Elementary School. This site has produced the most visually active and largest potential threat throughout the study. Although the cutback of this site measures less than at stake Nine the gully is much more active and is displacing much more material at the site of erosion. This gully consists of altering bands of differing sediment which contributes greatly to the relative instability (Figure 9).

**Figure 9. Active Erosion at Gully above Elementary School with Stake Sixteen near Edge (11/14/2008)**

The monitoring of cutback along the slip face must be continued paying especially close attention to the stakes that have shown activity. Stake number 16 is currently very close to the edge of the slip face and should be relocated before it falls into the gully.
