*Analysis of Hydrologic Factors at the Deer Run
Heights landslide in Jeffersonville, VT*

Nathaniel Weiss
Environmental Science – Natural Resources
Senior Thesis
4 May 2012

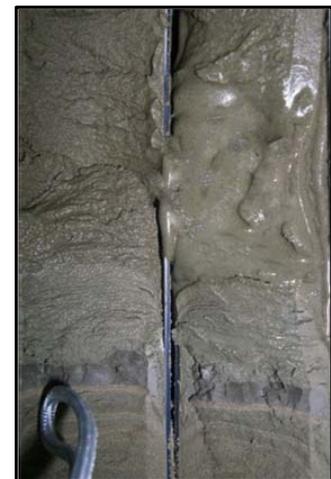
Figure 5. (Kanat, 2012)

Figure 5 shows a core sample taken at Deer Run Ridge. Notice the layers towards the bottom that show good cohesion; these layers consist of silts and clays that have a very low permeability, which means their ability to transmit fluid is poor. The low permeability of these layers leads to the accumulation of water above, and can be seen by the saturated sands; the saturated sands have poor cohesion and the water reduces frictional resistance. It is processes like these that retard the drainage of water, leading to loading that increases the mass above the slip surface (Figure 4), and may also lubricate the slip surface, thus increasing the driving forces. The slip surface is low in the slope, and is dominated by clays. Upon slope failure along this slip plane, the clays exhibit the strength—

cohesion and friction—of the sands seen in Figure 5. One can imagine that the accumulation of water, or loading, above a layer like that seen in Figure 5 would eventually trigger a landslide.
