**Glacio-lacustrine Deposits Create Landslide Hazards at  
Deer Run Heights in Jeffersonville, Vermont**

Michaela Forsberg  
Johnson State College  
20-July-07

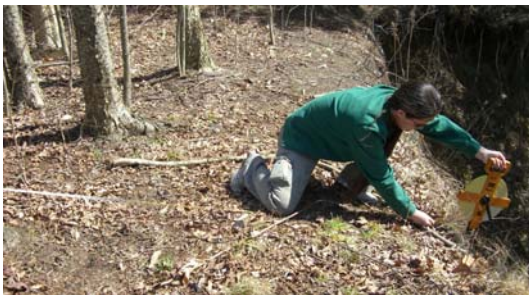
**Figure 2. Measuring Cutback**

The rate of cutback is monitored by using rebar stakes as a reference points and measuring directly in front of the stake to the edge of the ridge, and approximately 30° to either side (Figure 2). Measurements were taken at each stake along the ridge, and a compass and measuring tape were utilized. The iron rebar were placed at various intervals along the ridge and were only placed along the parts of the ridge where unstable soils were visually apparent. There are 18 stakes and the three measurements are taken at each stake except stake 13 and 18 where only two were taken. Stake number 19 was not used because it was only recently rediscovered in a patch high grass.
